ANNEX 1 MAPS

**Recommended Drill Sites
Mayuge District**

ANNEX 2 SITING SUMMARY SHEETS PER TARGET AREA

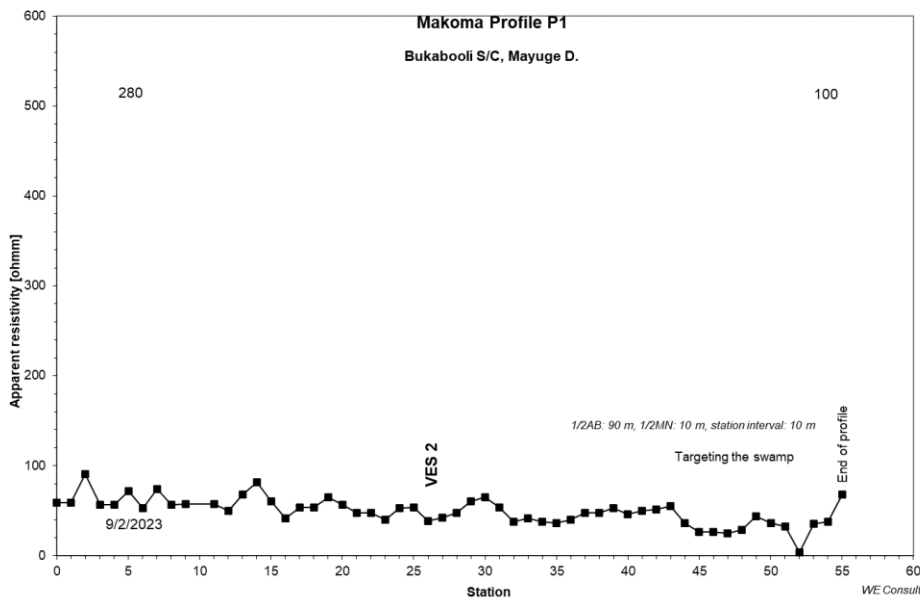
This profile had low values and anomalies were not clearly visible.

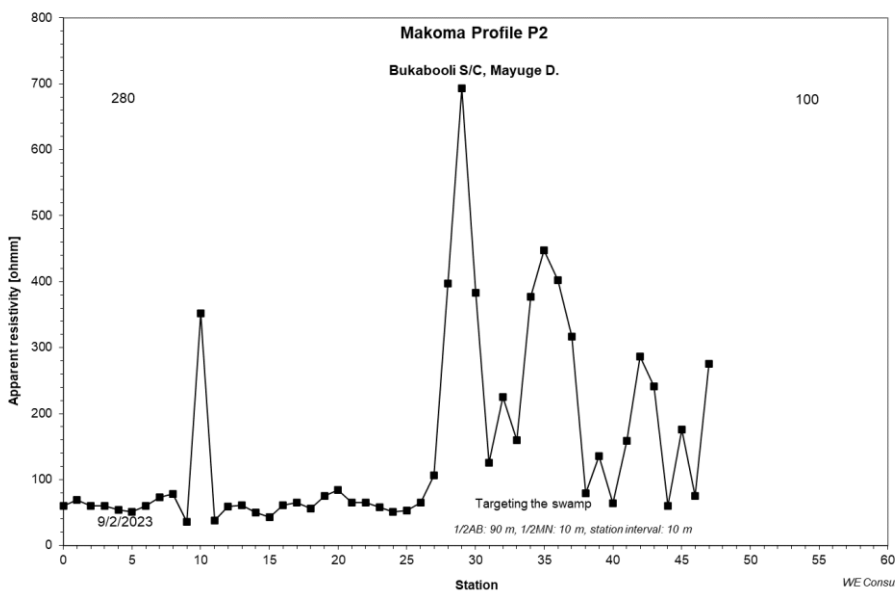
This profile indicated high values after 25 m from the start of the profile. There were laterites that could have caused the first spike in the results. A VES was carried out at an anomaly in the high resistivity section. The 30 m³/hr borehole was also carried out in a high resistivity area.

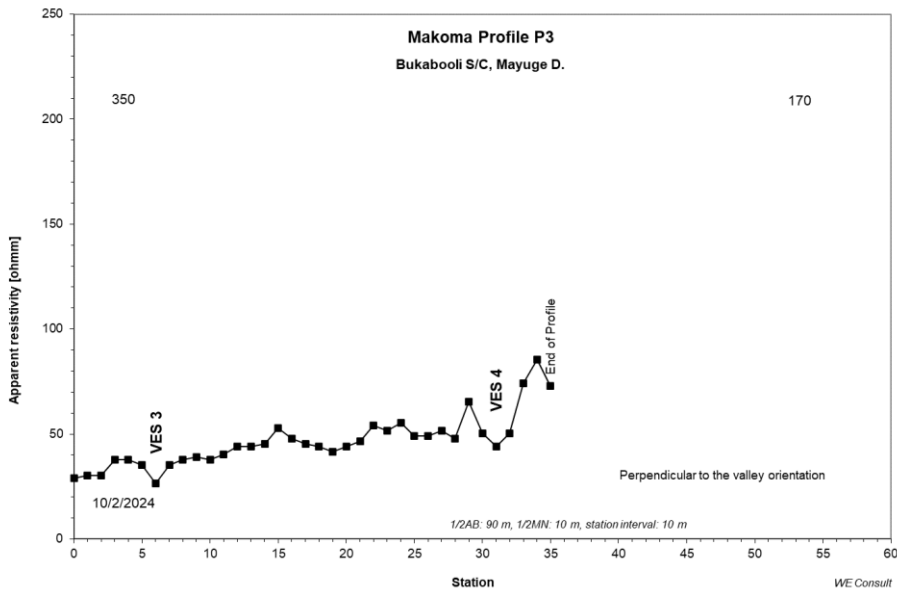
Carried out along the road towards the valley. It was stopped because of the flood zone.

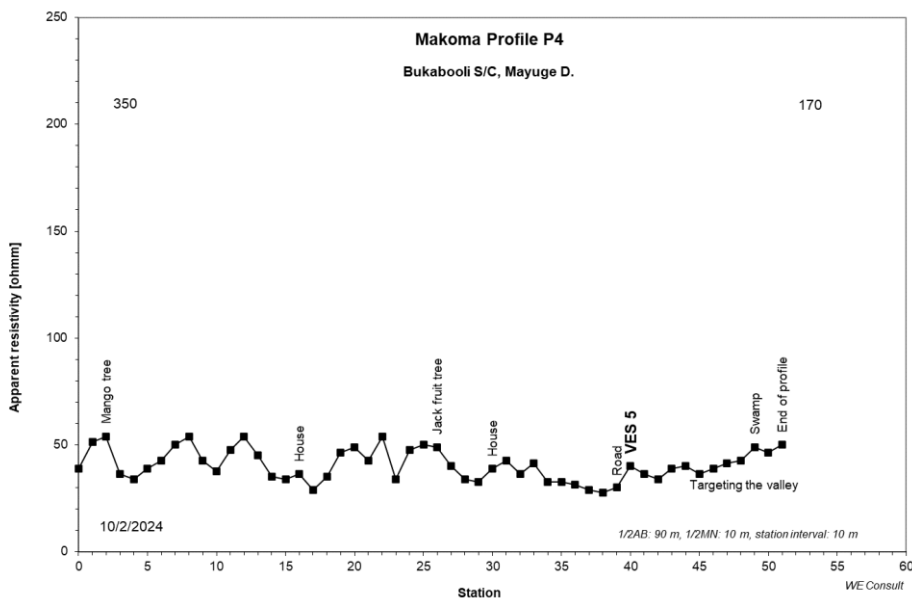
Profile stopped because the team could not cross the swamp.

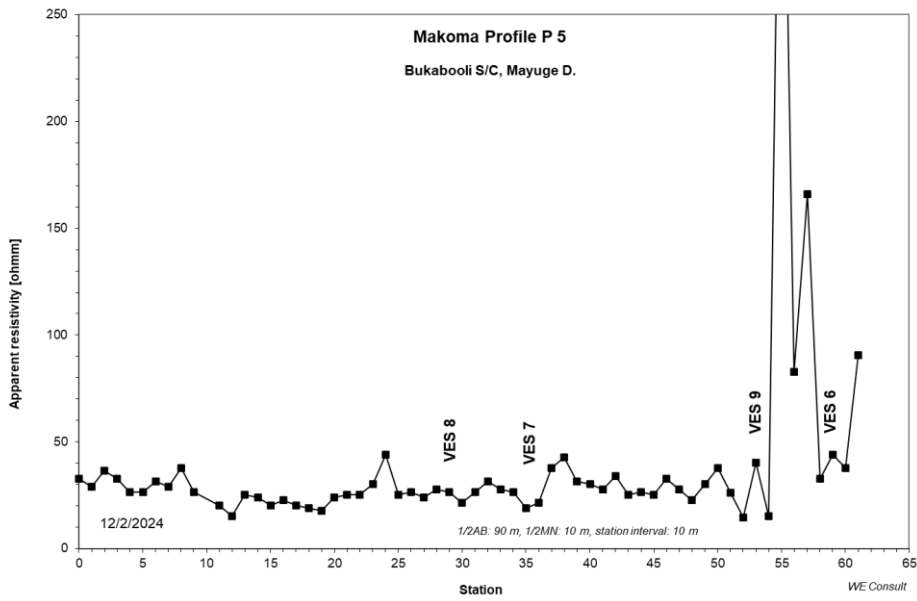
The target for this profile was a valley in this target area. This valley produced wide anomalies on profiles that were run perpendicular to it. The change in the resistivities could be caused by a change in the lithology.

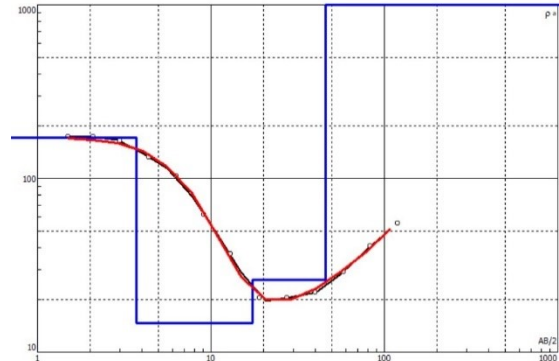
VES 1

Target Makoma
Profile P 1
Station 38
UTM X 569255
UTMY 36747

No	Depth	Res	Formation
1	175	3.7	Top soil
2	14.7	13	Clay or weathered rock
3	26	28	Clay
4	→	1000	Fractured rock

This was recommended as a drill site. It resembles a 30 m³/hr borehole.

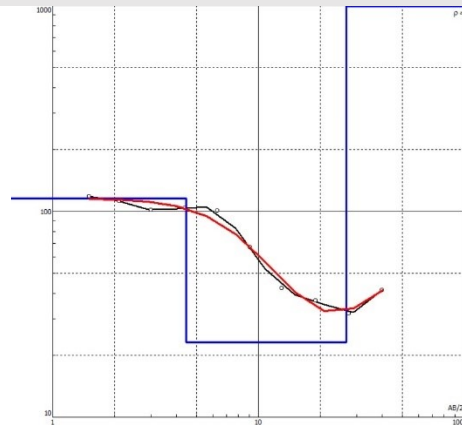
VES 2

Target Makoma
Profile P1
Station 26
UTM X 568593
UTMY 36666

No	Depth	Res	Formation
1	4.5	115	Top soil
2	26	23	Clay
3	→	2900	Sand

It shows a thick overburden. The shape resembles Calib V2. Calib V2 is a calibration of a shallow well. This can also be among the recommended Veses. The yield of this calibrated borehole is not known

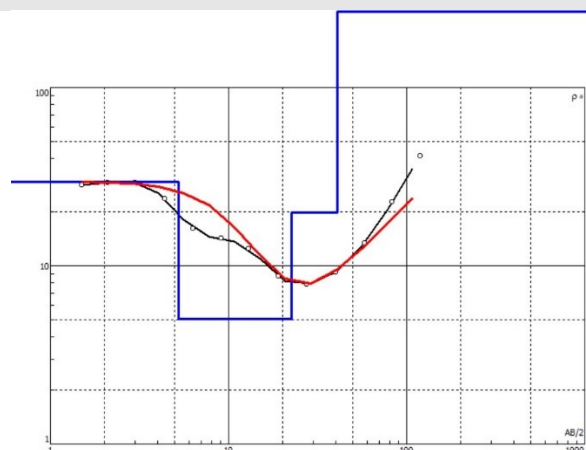
VES 3

Target Makoma
Profile P 3
Station 4
UTM X 567009
UTMY 38153

No	Depth	Res	Formation
1	1.5	75	Laterite
2	9.7	10	Clay
3	25.2	100	Weathered Rock
4	→	5000	Bedrock

This was carried out on an anomaly near the swamp. It has a kink that is interesting.

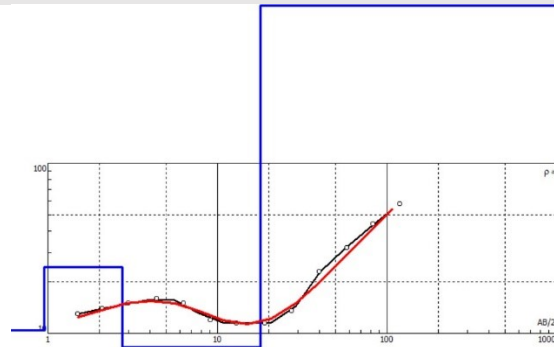
VES 4

Target Makoma
Profile P 3
Station 31
UTM X 566973
UTMY 37912

No	Depth	Res	Formation
1	1	10.4	Top soil
2	2.7	25	Laterite
3	18	8	Clay
4	→	5000

The sounding was carried out near the valley. The shape of this VES does not resemble any of the calibration VESes

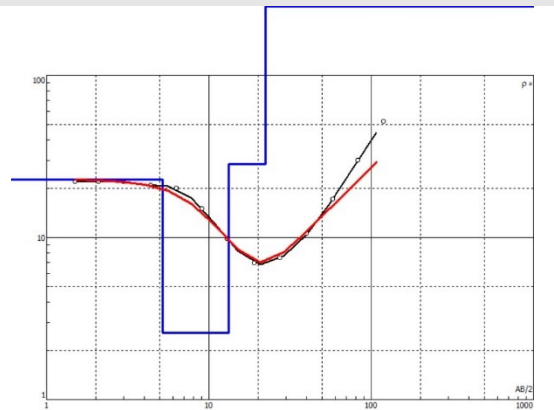
VES 5

Target Mugumya
Profile P 4
Station 38
UTM X 567089
UTMY 37629

No	Depth	Res	Formation
1	5	23	Top soil
2	13	2	Clay
3	22	28	Clay
4	→	5000	Bedrock

It shows a thick overburden but there is no kink in the bedrock.

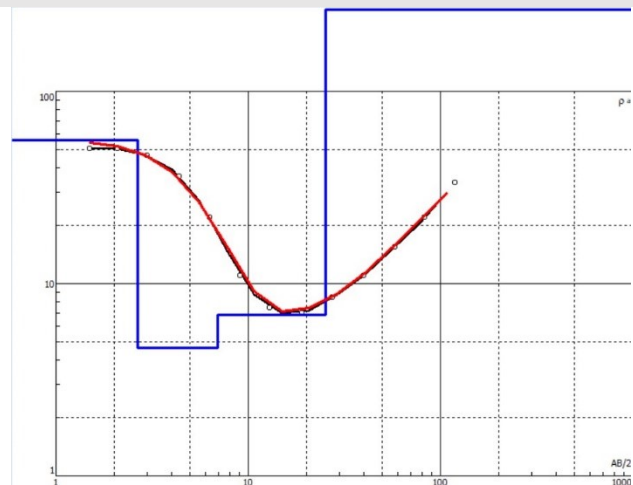
VES 6

Target Kirongo
Profile P 5
Station 58
UTM X 567107
UTMY 36492

No	Depth	Res	Formation
1	2.6	55	Top soil
2	7	4	Clay
3	25	7	Clay
4	→	5000	Bedrock

This was carried out on an anomaly near the swamp. It is among the recommended drill sites. It resembles the 30 cc borehole.

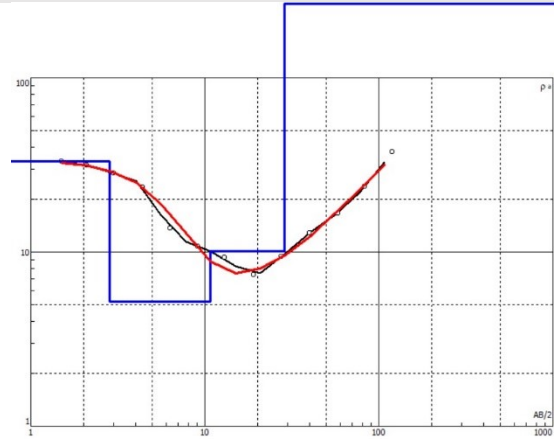
VES 7

Target Kirongo
Profile P 5
Station 4
UTM X 567023
UTMY 36705

No	Depth	Res	Formation
1	2	33	Top soil
2	10	5	Clay
3	28	10	Clay
4	→	5000	Bedrock

This is among the recommended as a drill sites. It resembles a 30 m³/hr borehole.

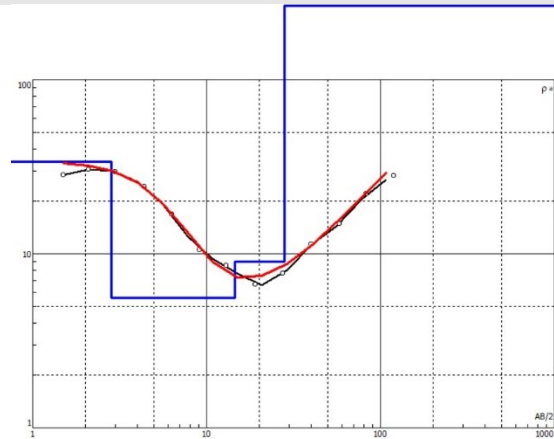
VES 8

Target Kirongo
Profile P 5
Station 29
UTM X 567017
UTMY 36766

No	Depth	Res	Formation
1	4.5	115	Top soil
2	26	23	Clay
3	→	2900	Sand

It resembles VES 7 but carried out at a higher elevation from the VES 7

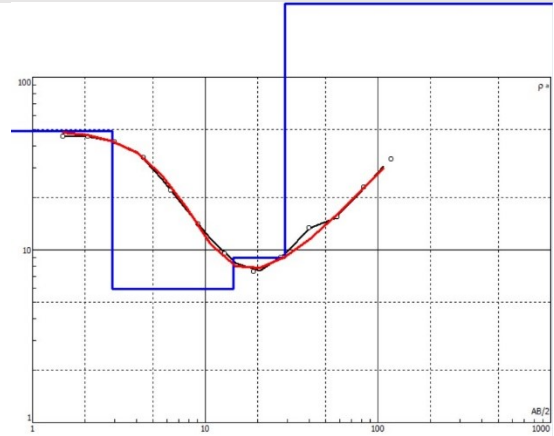
VES 9

Target Kirongo
Profile P5
Station 53
UTM X 567091
UTMY 36539

No	Depth	Res	Formation
1	2.8	48	Top soil
2	14	5	Clay
3	28.4	9	Clay
4	→	5000	Bedrock

This was carried out on an anomaly near the swamp. It has a kink that is interesting.

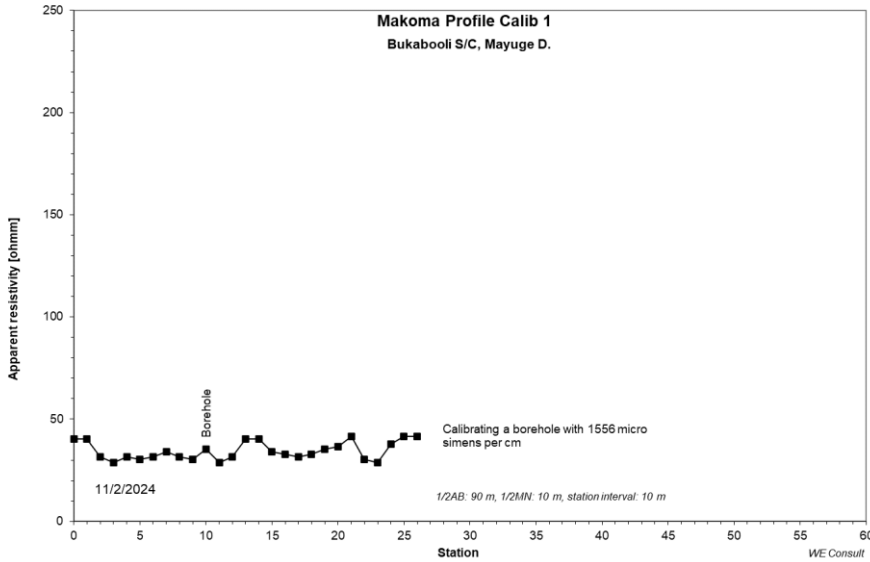
Carried out along the road targeting a hand pump borehole. This borehole is not on a clear anomaly

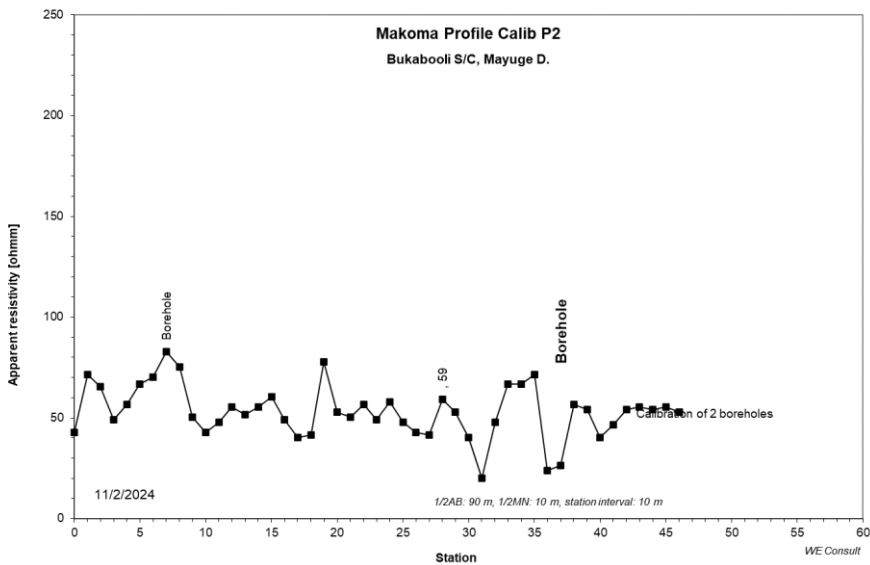
Targeting two boreholes, the results indicate that the first borehole (shallow well) is on a high value anomaly.

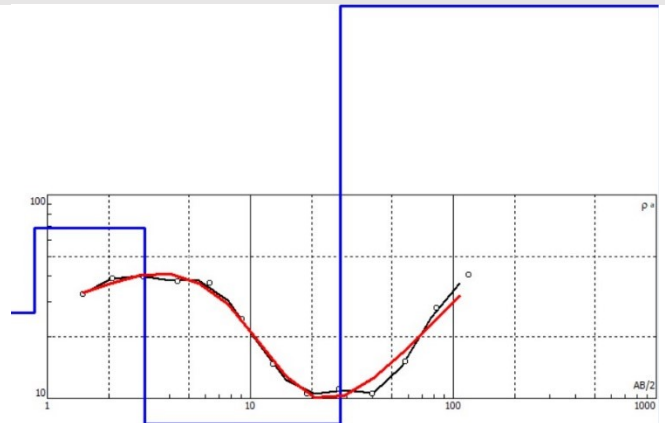
VES CALIB 1

Target Makoma
Profile Calib P 1
Station 8
UTM X 568269
UTMY 36185

No	Depth	Res	Formation
1	175	3.7	Top soil
2	14.7	13	Clay or weathered rock
3	26	28	Clay
4	→	1000

This was recommended as a drill site. It resembles a 30 m³/hr borehole.

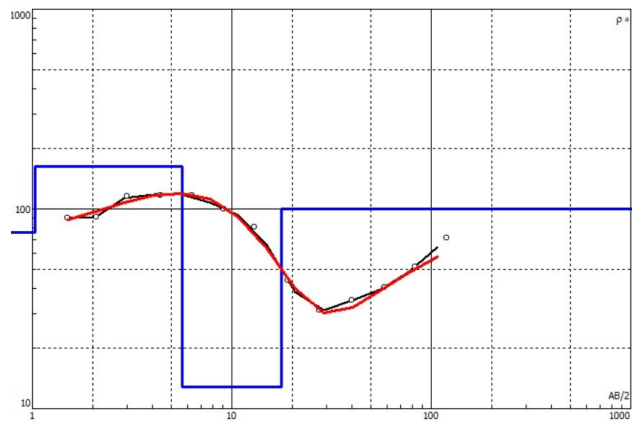
VES CALIB 2

Target Makoma
Profile Calib 2
Station 38
UTM X 567499
UTMY 37536

No	Depth	Res	Formation
1	4.5	115	Top soil
2	26	23	Clay
3	→	2900	Sand

It shows a thick overburden. Only one sounding, (VES 2) resembles this shallow well VES.

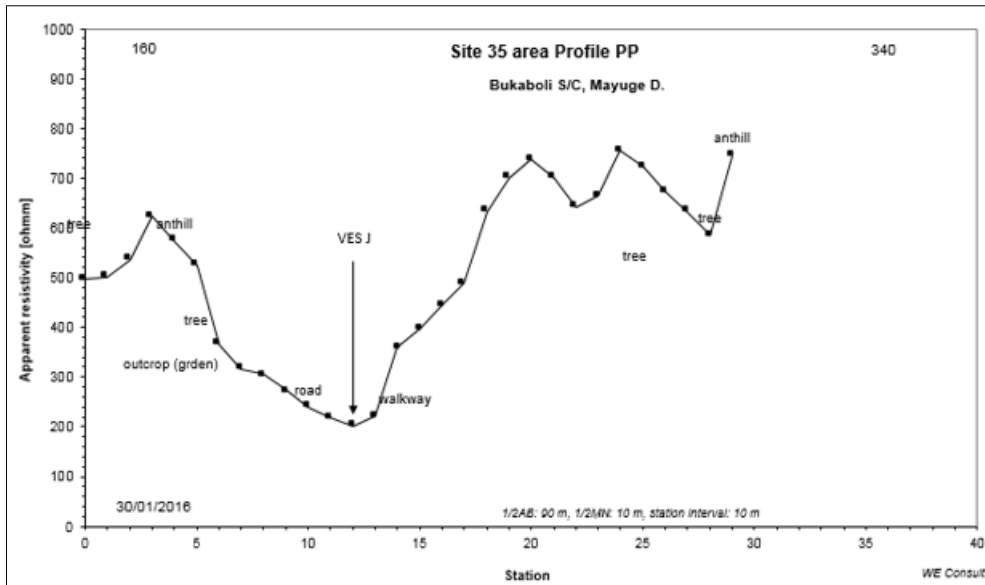
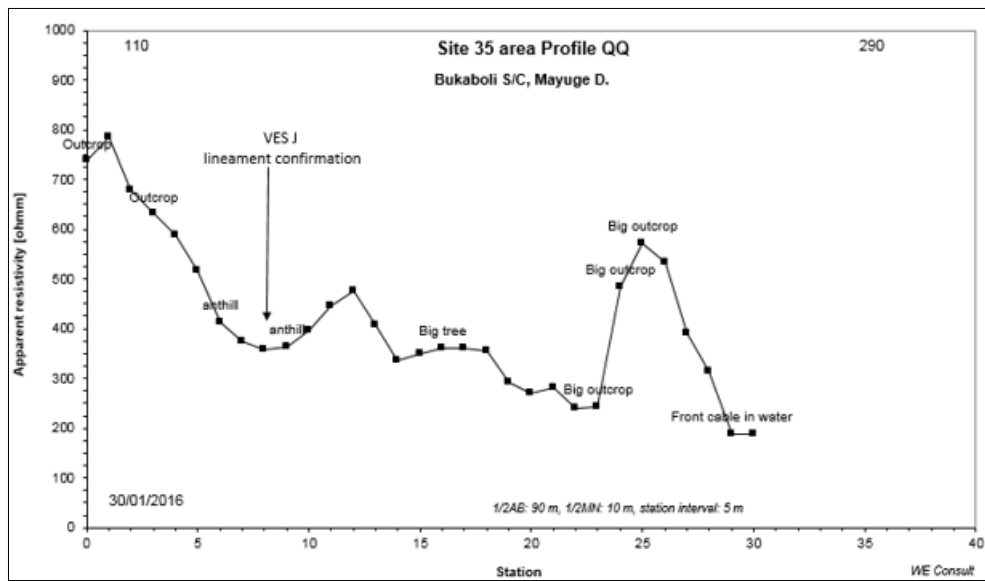
Previously sited and drilled borehole (VES J)

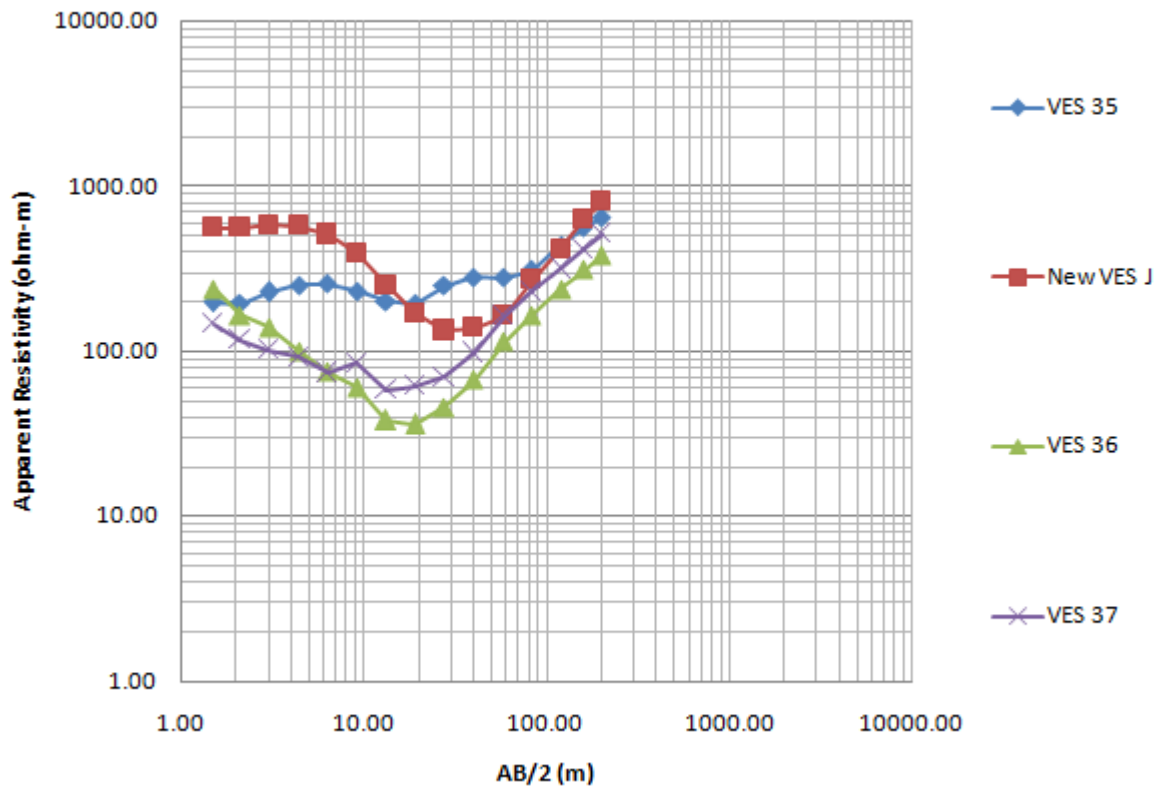
COMPARISON CURVES FOR MAYUGE
